SIO REFERENCE SERIES

DEEP MOORED INSTRUMENT STATION CRUISE REPORT

NORTH PACIFIC STUDY
Cruise 2

U.S.C.G.C. ACUSHNET
November 19 to December 19, 1968

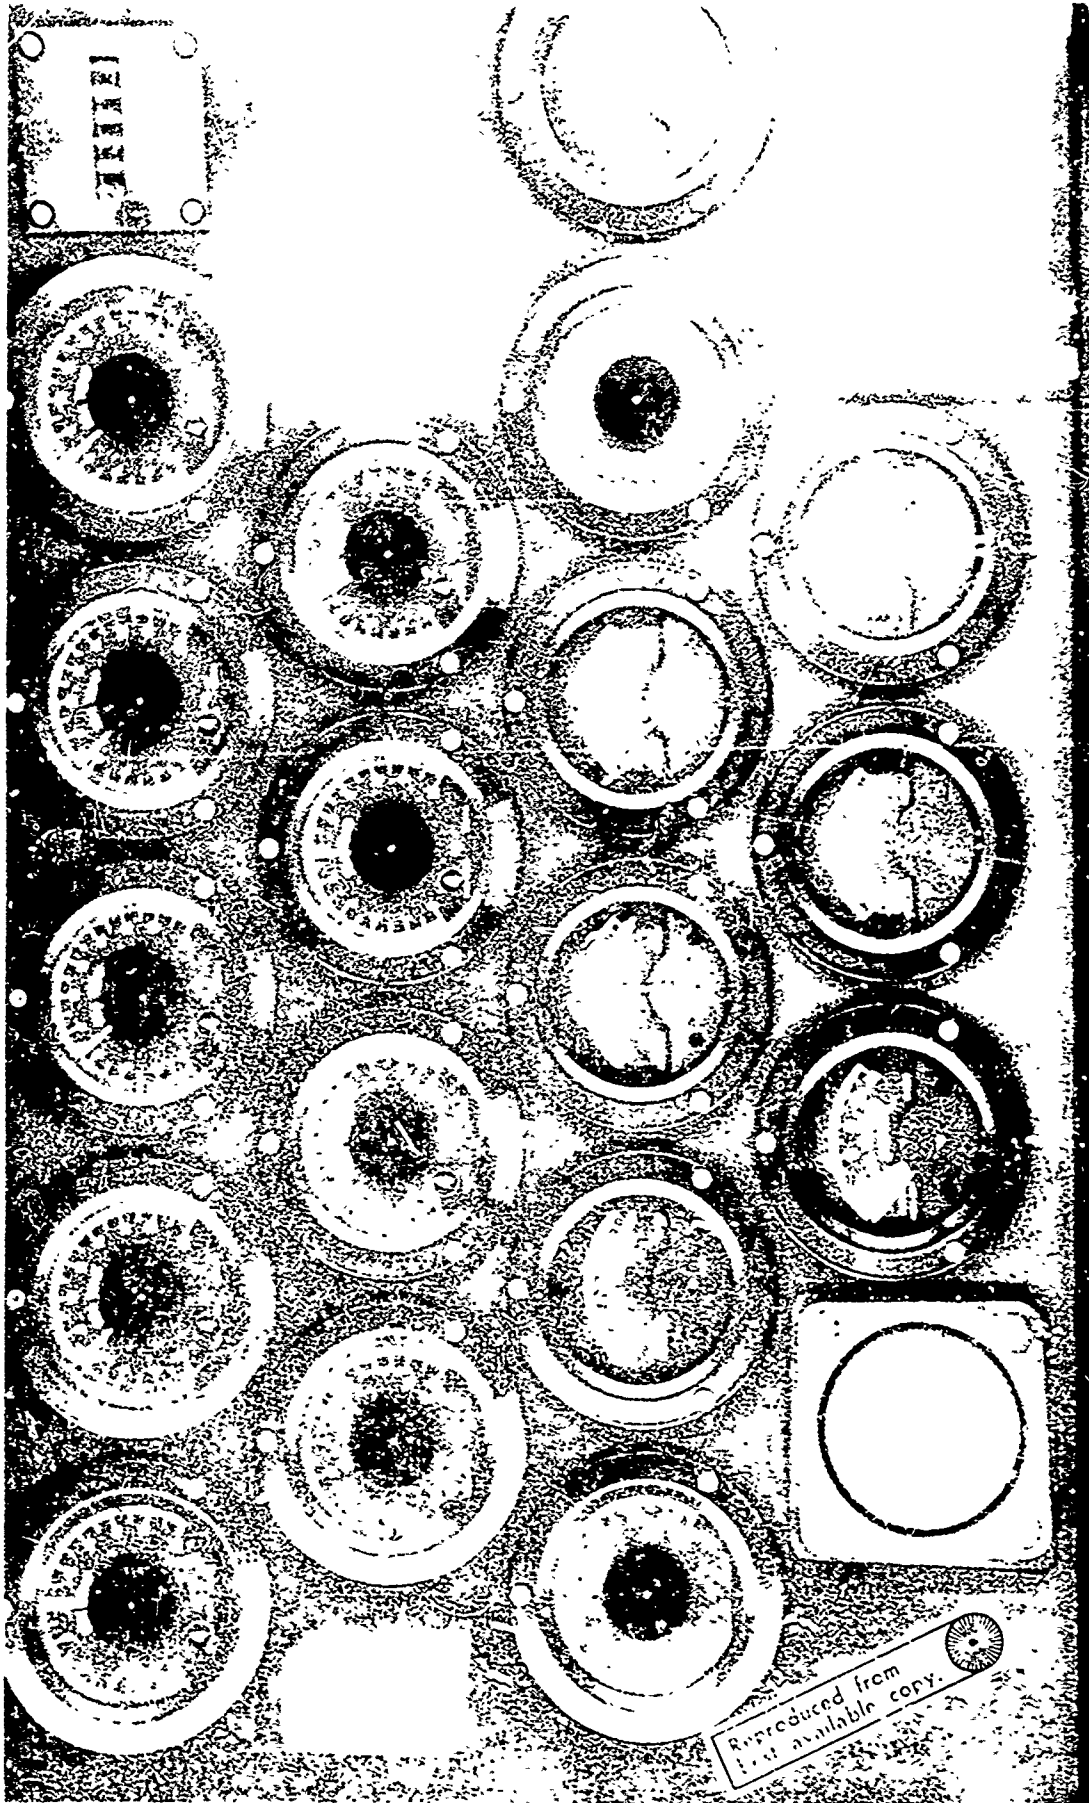
The cable clamps on the instrument lines through the bulkheads were corroded. Evidently the clips are not stainless steel.

All instrumentation with the possible exception of the load cell was operational and no meters were removed.

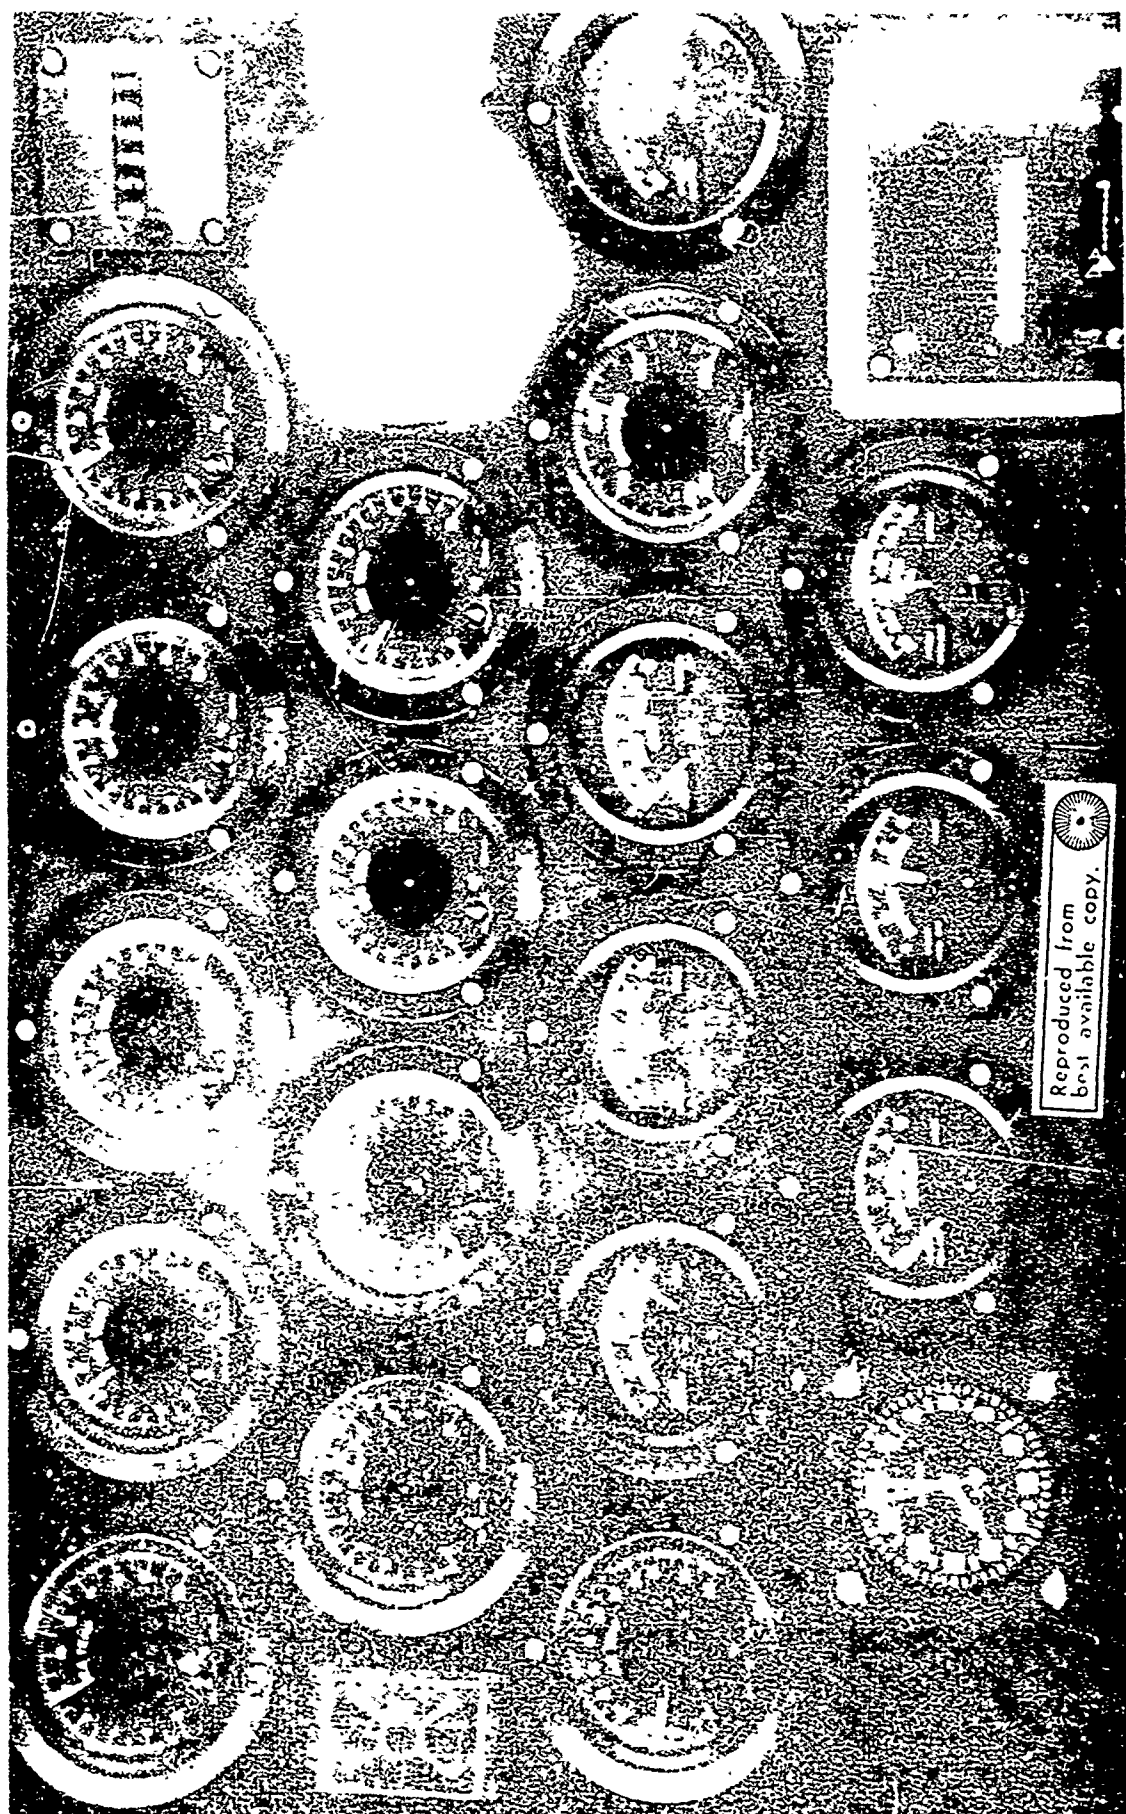
All cable clamps on the starboard side cables through the bulkheads were corroded.

When the new data camera was installed, its microswitch would not shut off the instrument box. Another camera had to be sent for and installed.

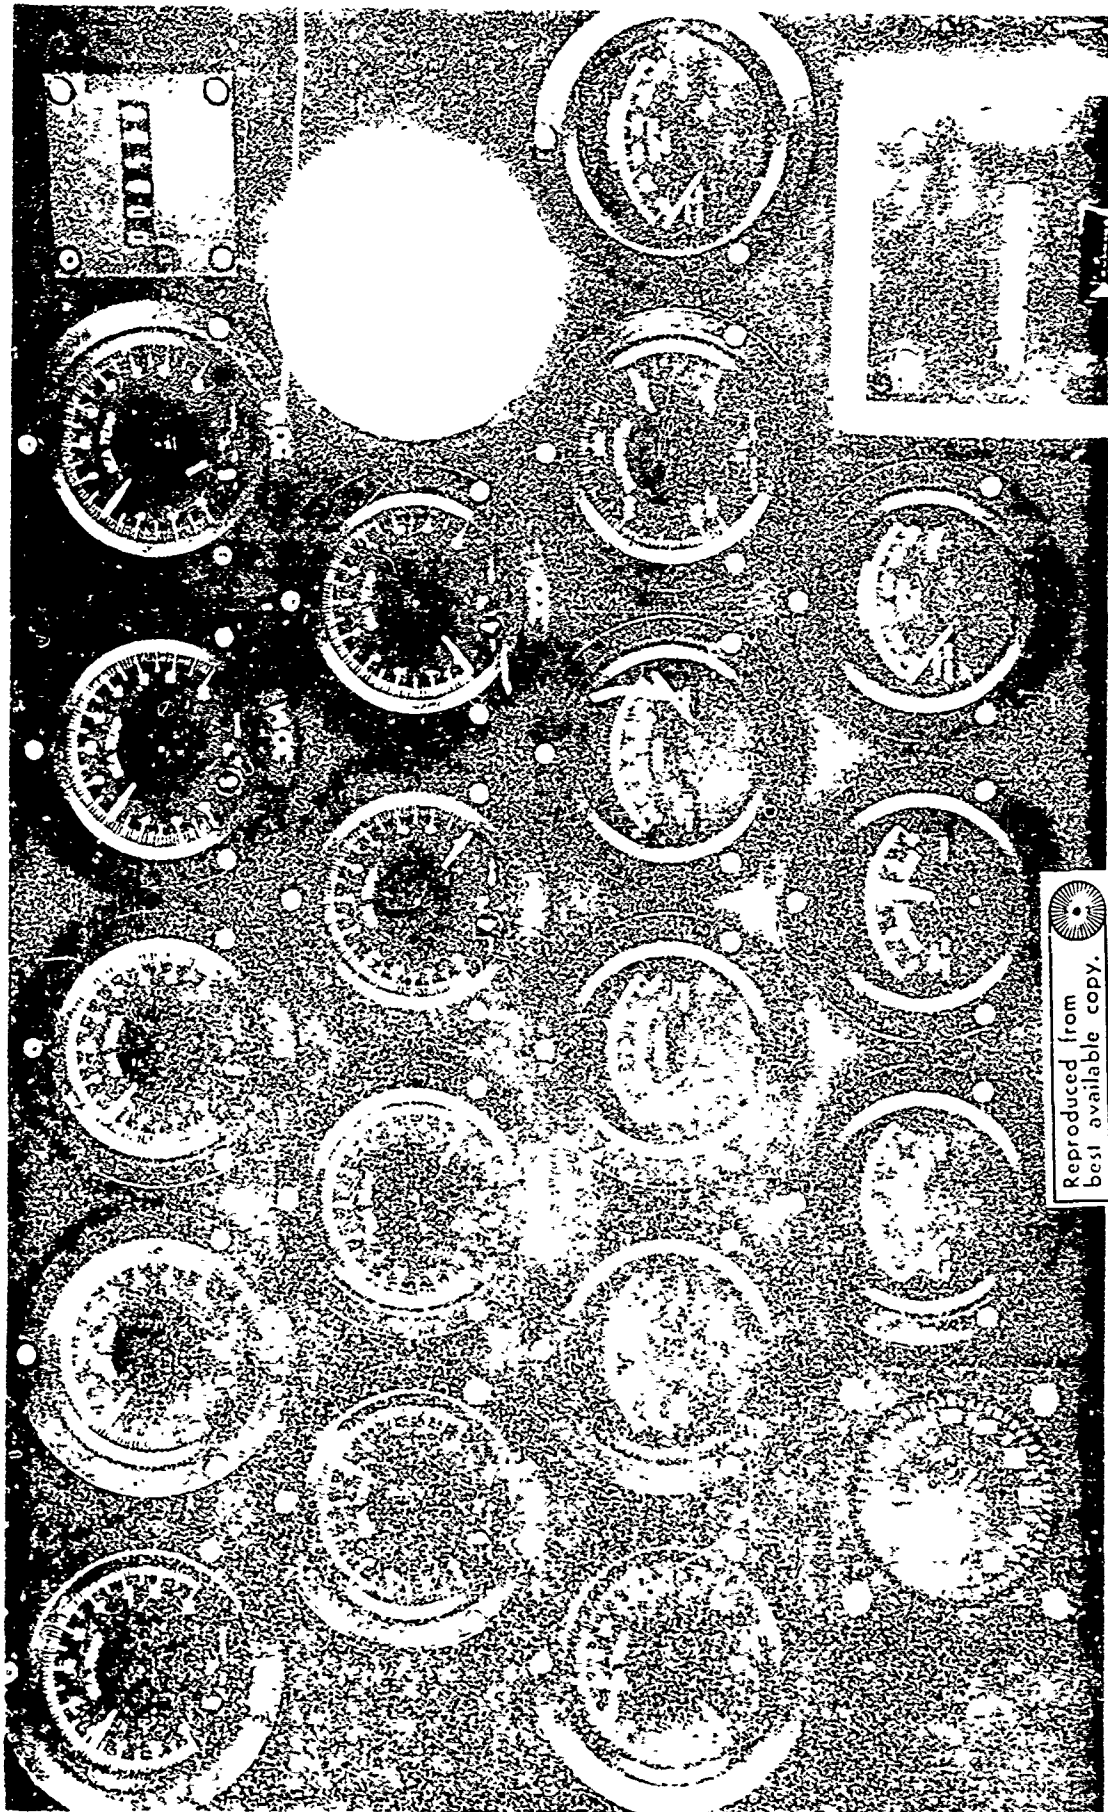
The 150 and 300m pressure indicators were removed as the pressure transducer circuits were open.

The line tension indicator was removed as it was inoperative.
